Contract #: 04-0120F4Cty: SF/ALA Rte: 80 PM: 13.2/13.9File #: 69.28**WELDING INSPECTION REPORT****Resident Engineer:** Pursell, Gary**Address:** 333 Burma Road**City:** Oakland, CA 94607**Report No:** WIR-015610**Date Inspected:** 13-Jul-2010**Project Name:** SAS Superstructure**OSM Arrival Time:** 700**Prime Contractor:** American Bridge/Fluor Enterprises, a JV**OSM Departure Time:** 1900**Contractor:** Zhenhua Port Machinery Company, Ltd (ZPMC), Changxing Island **Location:** Shanghai, China**CWI Name:** Li Yang**CWI Present:** Yes No**Inspected CWI report:** Yes No N/A**Rod Oven in Use:** Yes No N/A**Electrode to specification:** Yes No N/A**Weld Procedures Followed:** Yes No N/A**Qualified Welders:** Yes No N/A**Verified Joint Fit-up:** Yes No N/A**Approved Drawings:** Yes No N/A**Approved WPS:** Yes No N/A**Delayed / Cancelled:** Yes No N/A**Bridge No:** 34-0006**Component:** OBG**Summary of Items Observed:**

TRIAL ASSEMBLY YARD

OBG SEGMENT 9BE-9CE

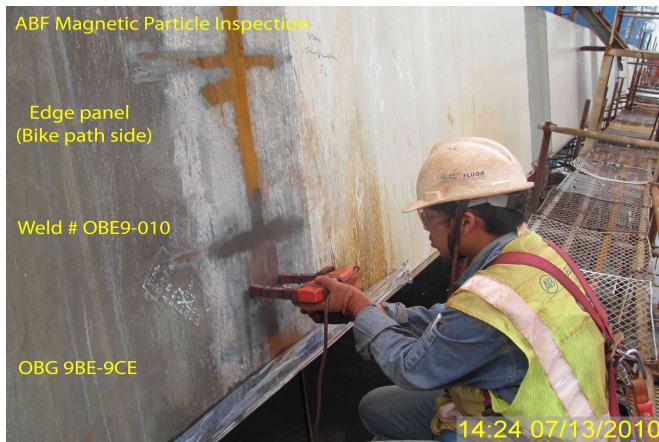
This QA Inspector Witnessed ABF personal performing Magnetic particle Testing (MT) on the edge panel splice weld between OBG segments 9CE and 9BE (Bike path side). Inspection was carried out on repair areas. Weld identification number were.

OBE9- 010 (OBG 9BE-9CE- E.P, BK side)

No relevant indications were observed.
